Report on Evaluation of Thin Hot Mix Asphalt Overlays and SR 164 Case Study

VDOT Materials Division

Pavement Design and Evaluation Section

July 30, 2004

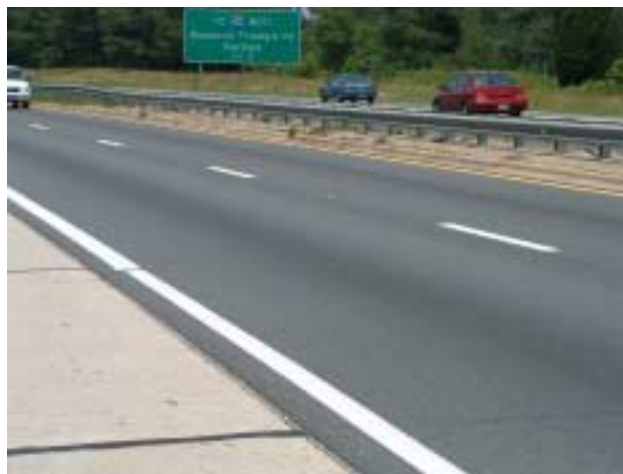
Photograph No. 1: Reflective crack (I 440 in Raleigh).

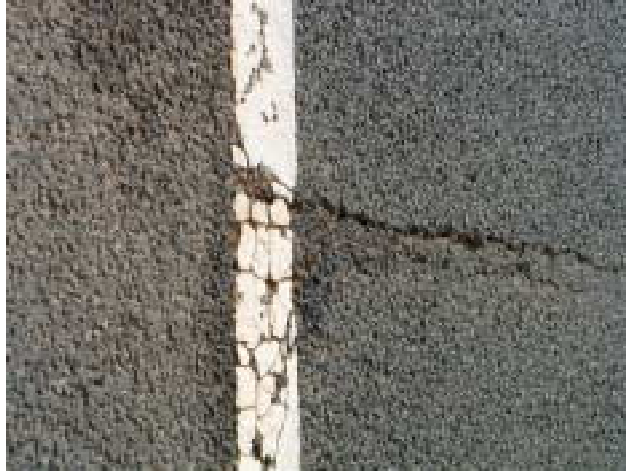
Photograph No. 2: Reflective crack seeping water (US 1 in Cary).

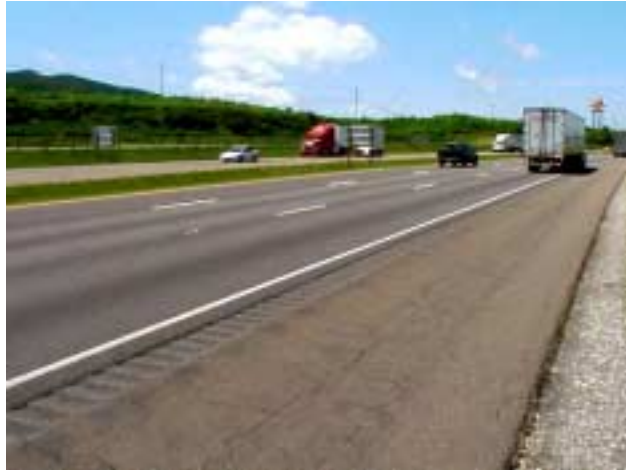
inches per mile. This was not a significant change in roughness. During a cursory visual survey in May 2004, the following distresses were noted: apparent patching of the center lane approximately 300 feet long, and isolated patches from the dislocation of snow plowable pavement markers. In general the surface of the THMACO appeared to be in good condition (see Photograph No. 4 below).

Photograph No. 4: I 81 in Wythe County, shoulder was not overlaid.

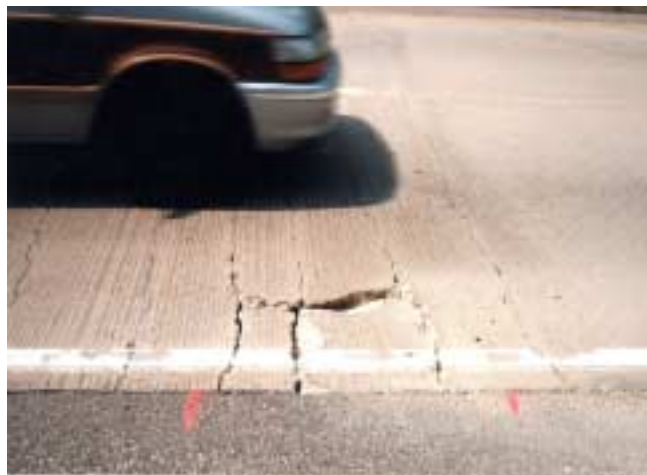
In June 2000 the pavements varied in condition relative to their thickness. The 9-inch thick CRCP appeared to be in good condition with limited “Y” cracking and no failures observed. The 8-inch CRCP

appeared to be in poor condition for its age, approximately 8 years old when surveyed in 2000, due to the observed frequency of patches and punchout failures. The majority of the failures (punchouts) in this pavement had occurred within a 0.4-mile long section of the 8-inch CRCP (see Photograph No. 5). The punchouts indicated a structural failure within the CRCP system. These failures may have been caused by a failure of the concrete or the pavement's supporting layers. The presence of fines on the asphalt shoulders indicated that water was getting into the pavement system and has washed out material from the supporting layers (see Photograph No. 6). Possible sources for this water were the open longitudinal joints between the concrete pavement and asphalt shoulders, and the unpaved portion of the inside shoulders which sloped (drained) towards the pavement. Additionally, low severity spalling of the transverse cracks was noted.

Photograph No. 5: Punchout on SR 164 Eastbound, MP 1.46.

Based on the conditions observed, planned increases in traffic, and existing grade constraints, it was recommended that Alternative 5 (full-depth patch failures, install edge drains, seal joints, and placement of a thin hot mix asphalt concrete overlay on the 8-inch CRCP) be performed. This alternative provides for repair of existing failures, correction of the conditions that probably initiated these failures, and an overlay to further reduce the intrusion of water through the pavement surface. Not placing an overlay can allow infiltration of surface water into spalled transverse cracks.

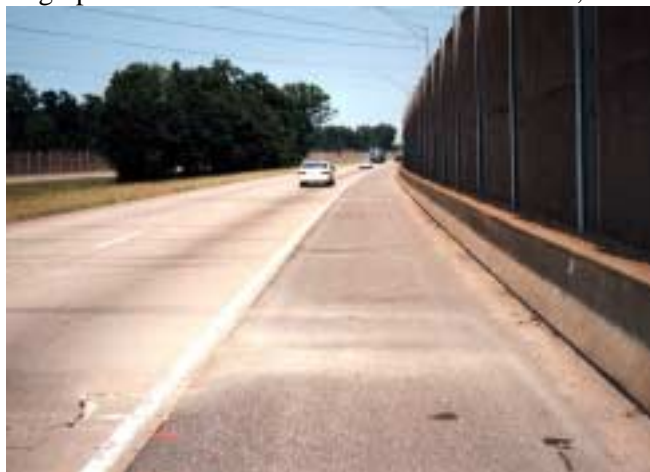
Photograph No. 6: Fines on shoulder near punchout shown in Photograph No. 5.

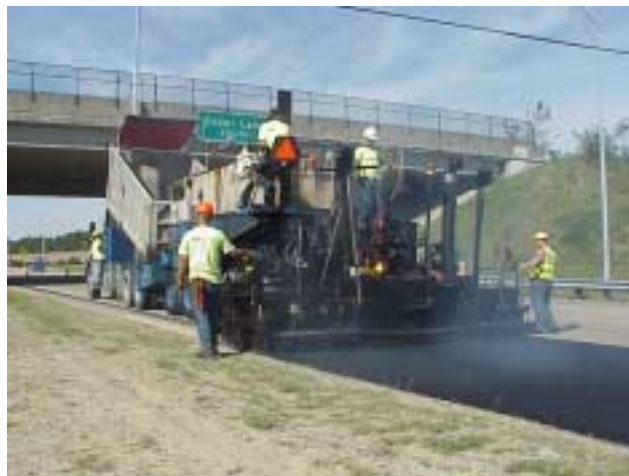
Photograph No. 7: Application of THMACO on SR 164, October 2003 (MP 2.34, WBL).

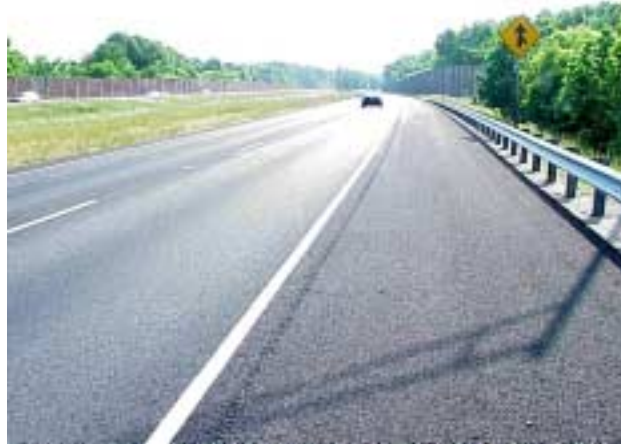
The initial post rehabilitation condition survey of the 8-inch CRCP indicates that there were no visible surface distresses in the THMACO at the time of the survey. The 9-inch CRCP had not been surveyed since completion of the rehabilitation project. However, cursory observations indicate that it is still

Photograph No. 8: SR 164 THMACO surface after one winter, May 2004 (MP 1.10, EBL).
